DEPARTMENT OF TRANSPORTATION

Contract #: 04-0120F4Cty: SF/ALA Rte: 80 PM: 13.2/13.9File #: 69.28**WELDING INSPECTION REPORT****Resident Engineer:** Siegenthaler, Peter**Address:** 333 Burma Road**City:** Oakland, CA 94607**Report No:** WIR-021279**Date Inspected:** 26-Jan-2011**Project Name:** SAS Superstructure**OSM Arrival Time:** 1500**Prime Contractor:** American Bridge/Fluor Enterprises, a JV**OSM Departure Time:** 300**Contractor:** Zhenhua Port Machinery Company, Ltd (ZPMC), Changxing Island **Location:** Shanghai, China**CWI Name:** Yu Jiao**CWI Present:** Yes No**Inspected CWI report:** Yes No N/A**Rod Oven in Use:** Yes No N/A**Electrode to specification:** Yes No N/A**Weld Procedures Followed:** Yes No N/A**Qualified Welders:** Yes No N/A**Verified Joint Fit-up:** Yes No N/A**Approved Drawings:** Yes No N/A**Approved WPS:** Yes No N/A**Delayed / Cancelled:** Yes No N/A**Bridge No:** 34-0006**Component:** OBG Segment Assembly**Summary of Items Observed:**

OBG Segment 13AE / Bay 14

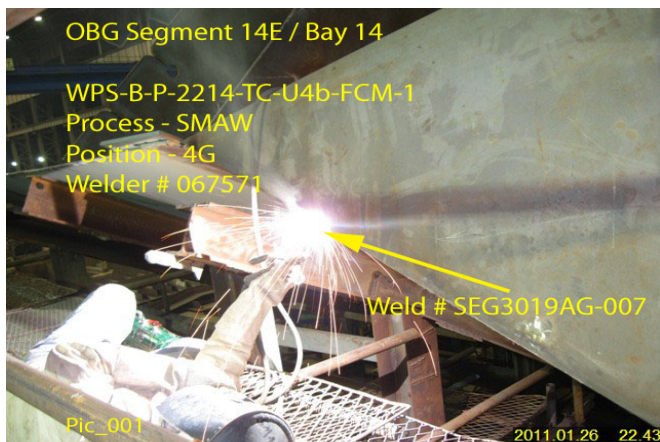
OBG Segment 14E / Bay 14

Shielded Metal Arc Welding (SMAW) in the 4G position of EP to SP weld # SEG3019AG-007. The welder is identified as 067571. ZPMC Quality Control (QC) is identified as Zhang Hai Feng. The welding variables recorded by QC appeared to comply with WPS-B-P-2214-TC-U4b-FCM-1. See attached photograph Pic_001
